AFFDL-TR-72-64 VOLUME III

DEVELOPMENT OF AN UNDERSTANDING OF THE FATIGUE PHENOMENA OF BONDED AND BOLTED JOINTS IN ADVANCED FILAMENTARY COMPOSITE MATERIALS

VOLUME III. FATIGUE ANALYSIS AND FATIGUE MODE STUDIES

A. C. Fehrle, J. R. Carroll, S. M. Freeman, et al. Lockheed-Georgia Company Marietta, Georgia

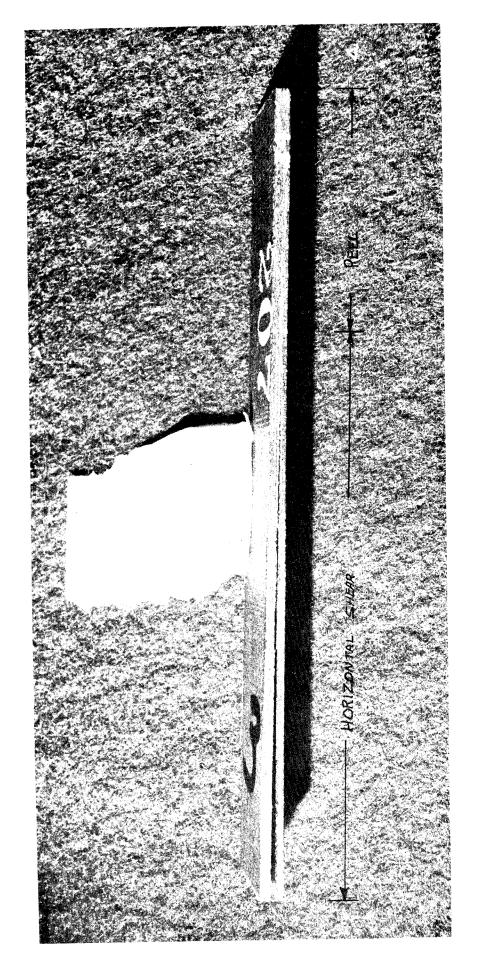
The shear and peel failure modes were defined utilizing a failed 15-ply flexure specimen. The specimen was subjected to a beam bending load and initial failure was a shear failure along the midplane of the laminate. This initial failure plane is evident in Figure 74. The specimen was then physically pulled apart by hand, resulting in a true peel or cleavage mode of failure over the remainder of the specimen. In Figure 75 the facing fractured surfaces are shown and the two failure mode zones are defined. Electron scan photomicrographs of these two surfaces in the transition zone, Figure 76, illustrate the difference between the shear and peel modes of failure. The difference is still more pronounced in the 560X magnification of the shear surfaces, Figure 77, and in the 570X magnification of the peel surfaces, Figure 78. The shear failure of the resin between the fibers has the appearance of being stressed in biaxial compression and tension (shear) with failure occurring normal to the tensile load.

Figure 74 Boron Flexure Specimen - Horizontal Shear Failure

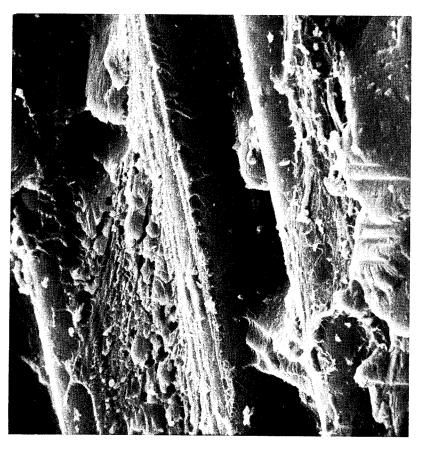
- NOTES: (1) Surface A does not mate identically to Surface B.
- Dotted line indicates area where failure mode shifted from horizontal shear to peel. (2)
- (3) Arrow A indicates shear zone.
- (4) Arrow B indicates peel zone.
- testing and extended from one end toward the other for approximately three-fourths of the specimen The peel zone was produced by extending the intralaminar separation for the remainder of Intralaminar separation of the specimen as a result of horizontal shear occurred during flexural the specimen length by pulling apart the delaminated ends by hand. (5)

Facing Fracture Surfaces Along the Fracture Plane of a Boron-Epoxy Longitudinal Flexure Specimen Figure 76

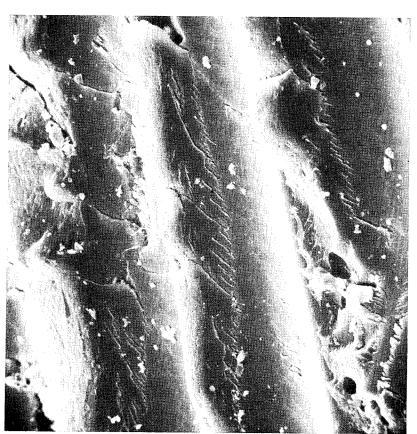
Figure 77 Facing Surfaces in the Horizontal Shear Fracture Zone of a Boron-Epoxy Longitudinal Flexure Specimen

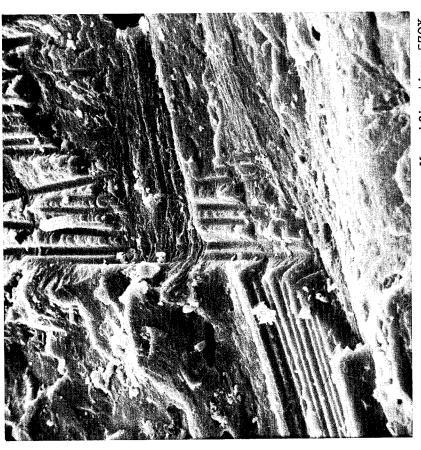
Figure 78 Facing Surfaces in the Peel Fracture Zone of a Boron-Epoxy Longitudinal Flexure Specimen

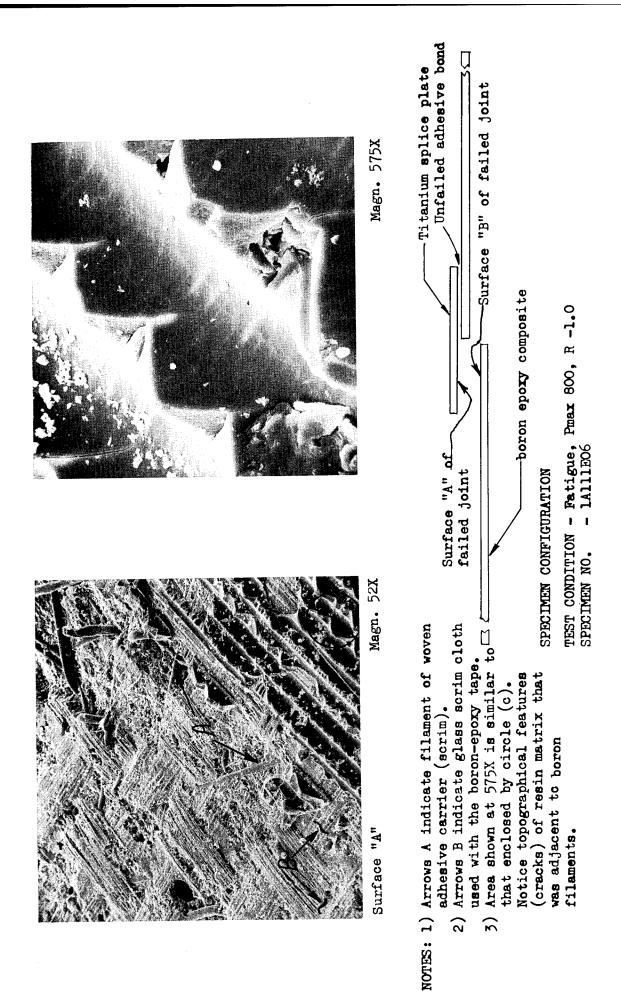
The 52X magnification, Figure 79, of specimen –E06 shows the general appearance of the failed surface whereas the 575X magnification of the same failure surface shows finer details of the fracture mode. The saw tooth effect so prominent in these photos indicates that the reversal in specimen loading resulted also in the reversal of principal tension stress within the resin causing the tensile failures. This fracture mode differs from the basic shear mode as evidenced on the flexure specimen. On the flexure specimen the tensile fractures were in one direction and were not as sharply defined whereas on this R = -1.0 fatigue failure the fractures are sharp, well defined, and the tensile fractures are nearly normal to each other. The 50X magnification, Figure 80, of specimen –E02 shows the general appearance of the failed surface whereas the 500X magnification of the same failure surface shows details of the fracture mode. The tensile fracture that was defined in the flexure specimen as a shear mode is also illustrated in this photograph. However, the fracture for this specimen has a rounded appearance along the length of the tension fracture indicating the direction of the principal tensile stress is varying through the thickness of the resin.

Figure 79 Typical View of Fracture Surface "A" in Adhesive Bonded Joint Specimen

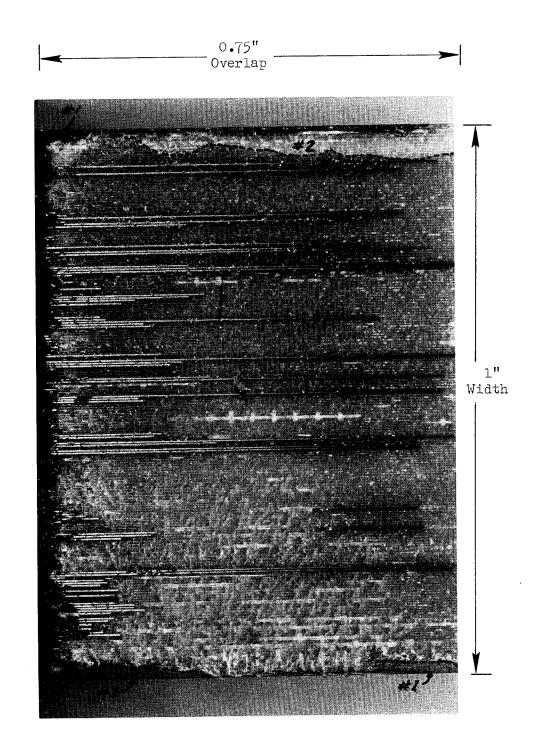
Figure 81 IA111A03 - Failure Surface "A"
Titanium Splice Plate

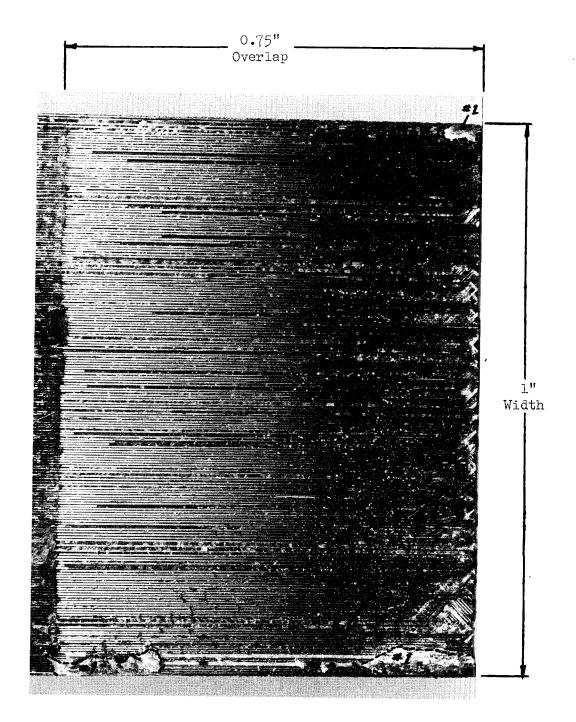
In Figure 82, Section #1 is a cohesive failure of the adhesive adjacent to the titanium splice plate and coincides with Section #1 in Figure 81. The remainder of the fracture was shear between the resin matrix and boron fiber leaving the upper surface of the boron fibers exposed. A 100X magnification of a portion of this area is shown in Figure 84. This photograph is of the facing surface to that shown in Figure 83, and the fractures in the resin between the fiber are mating fractures to those along the ridges in Figure 83.

Figure 82 IA111A03 - Failure Surface "B"
Boron Adherend

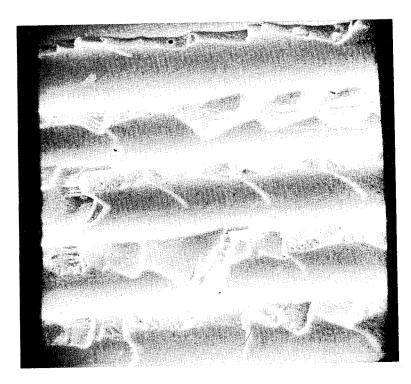
Figure 83 IA111A03 - Failure Surface "A" 200X Magnification

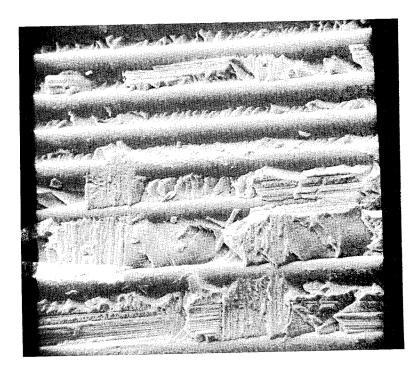
Figure 84 IA111A03 - Failure Surface "B" 100X Magnification

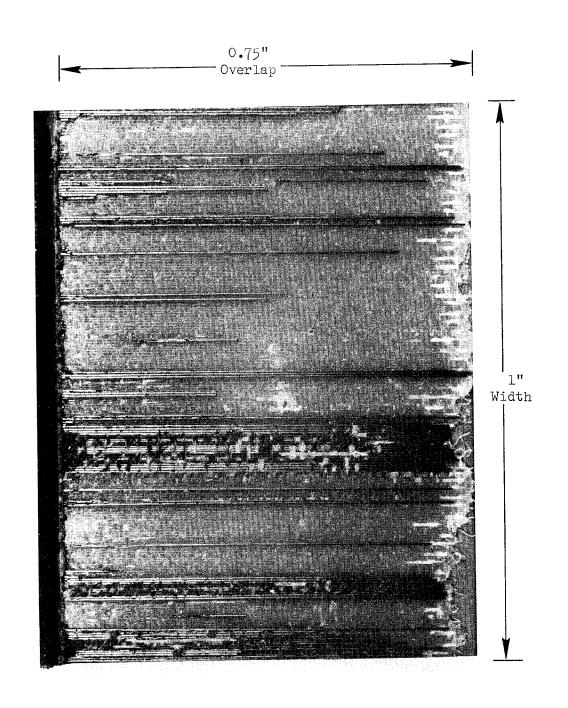
This is a Configuration A specimen having boron adherends and a titanium splice plate. The specimen was subjected to static loading in tension and failed at 4600 psi. Figures 85 and 86 show failure Surfaces A and B respectively. The major modes of failure for this specimen were shear between the resin matrix and the boron fiber and tensile failure of a large number of boron fibers. A small area across the end of the titanium splice plate had an adhesive failure between the EA9601 adhesive and the titanium splice plate. Only one high magnification, 100X, photograph was taken of this specimen, Figure 87. This photograph shows the exposed fiber of Surface B and the broken resin between the fibers. The appearance of this fracture mode is similar in nature to that shown in Figure 84 for specimen No. IA111A03 (fatigue test, R = +0.1). Again by this similarity it may be indicated that the direction of load is the major controlling factor in the type of failure mode.

Figure 85 IA111D01 - Failure Surface "A" Titanium Splice Plate

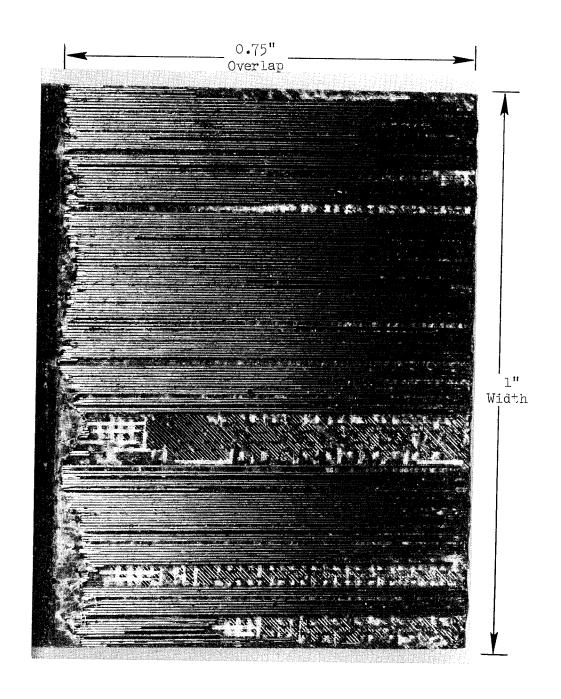
Figure 86 IA111D01 - Failure Surface "B"
Boron Adherend

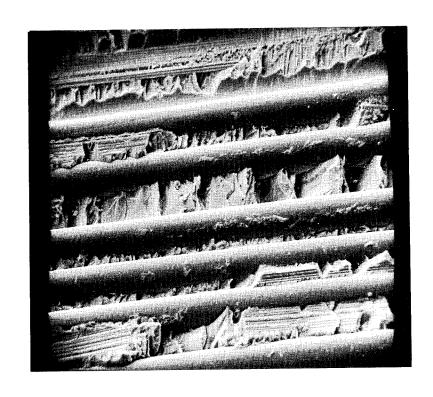
Figure 87 IA111D01 - Failure Surface "B" 100X Magnification

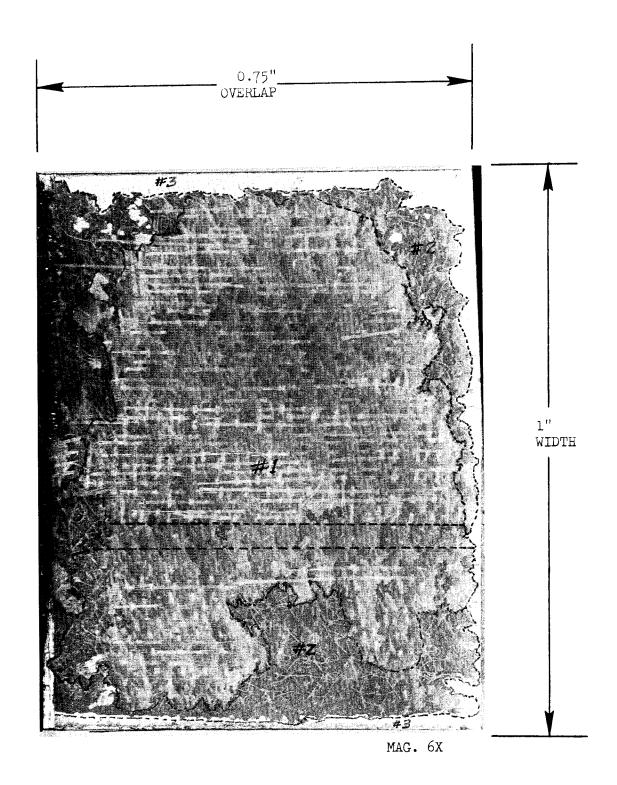
Figure 88 IA111D09 Faiture Surface "A" - Titanium Splice Plate

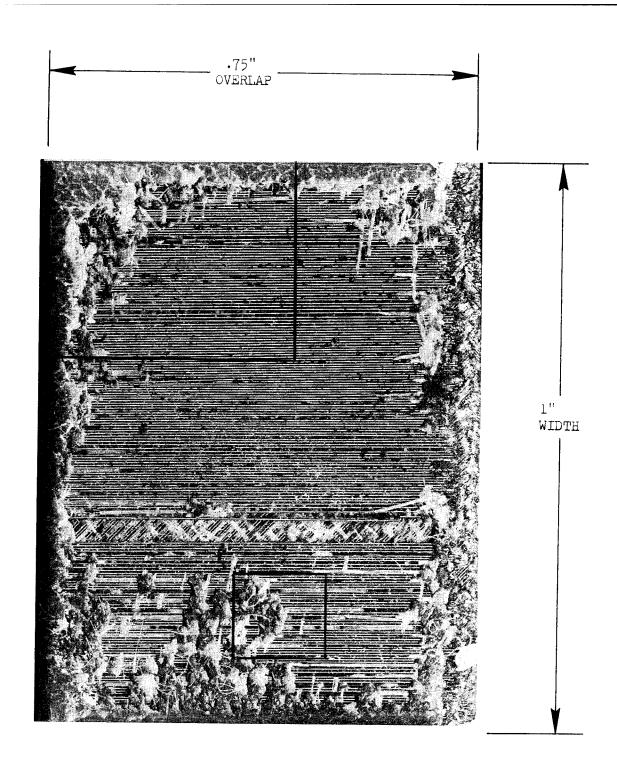
The fracture surface of Figure 89 is a mirror image of the splice plate surface shown in Figure 88. The small square area outlined in this figure is the area selected for investigation by SEM photomicrographs. Figure 90 is the larger area outlined in Figure 89 and was used as a map for more extensive investigation. Three different failure modes were studied with this specimen. One failure mode, Figure 91, was associated with shear at the adhesive surface; the second, Figure 92, was associated with shear within the adhesive along the adhesive scrim carrier (cohesive mode); and the third, Figure 93, illustrated once again the resin/fiber interface shear mode associated with compression loading.

Figure 89 IA111D09 Failure Surface "B" - Boron Adherend - Mag. 6X

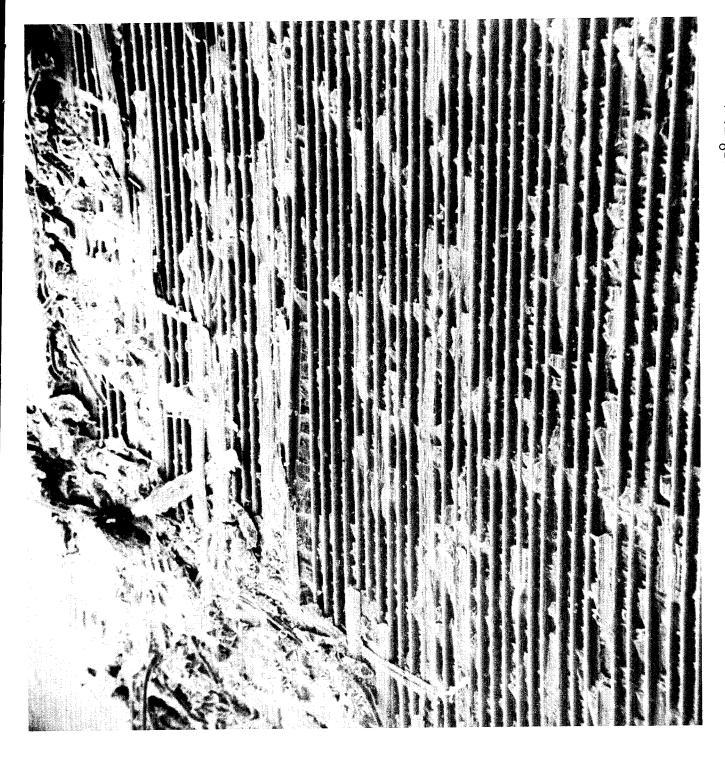
IA111D09 Failure Surface "B" Map - 40X Magnification, 45° Tilt (Reference Figure 89) Figure 90

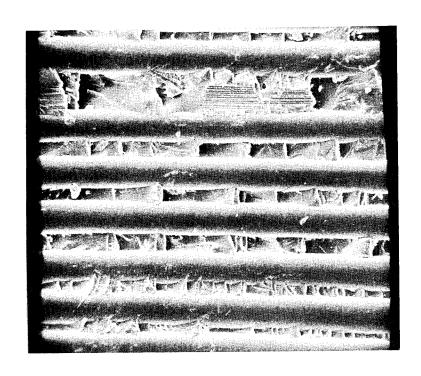
Figure 93 IA111D09 - Surface "B"
100X Magnification, 0° Tilt
(Reference Figure 90)

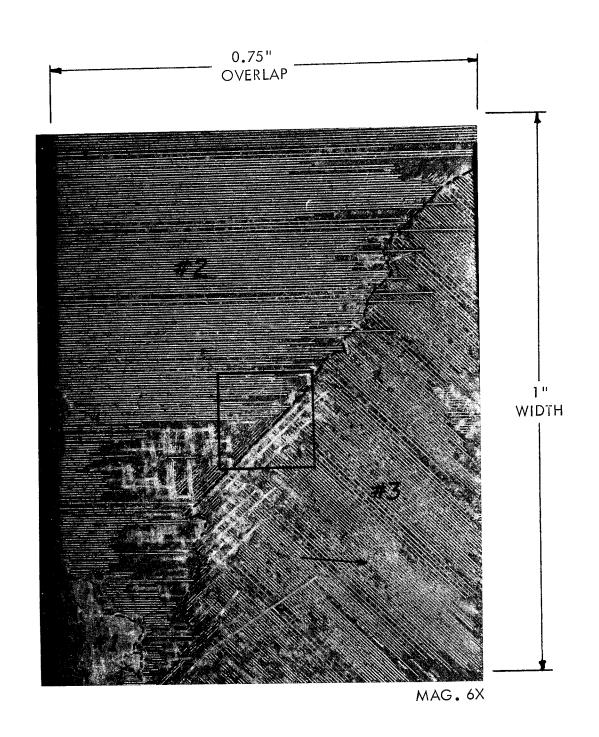
The square areas outlined in Figures 94 and 95 are the areas investigated by SEM photomicrographs. Figure 96 is the area outlined in Figure 94 and was used as a map for further investigation. Two different failure modes were evaluated at higher magnifications. Figure 97 illustrates two different failure modes. One failure mode is a shear failure between the resin and the first layer of boron parallel to the load direction. This failure mode is the same as that previously defined for tension-tension fatigue loading. However,

Figure 94 IA113A01 Failure Surface "A"
Boron Splice Plate

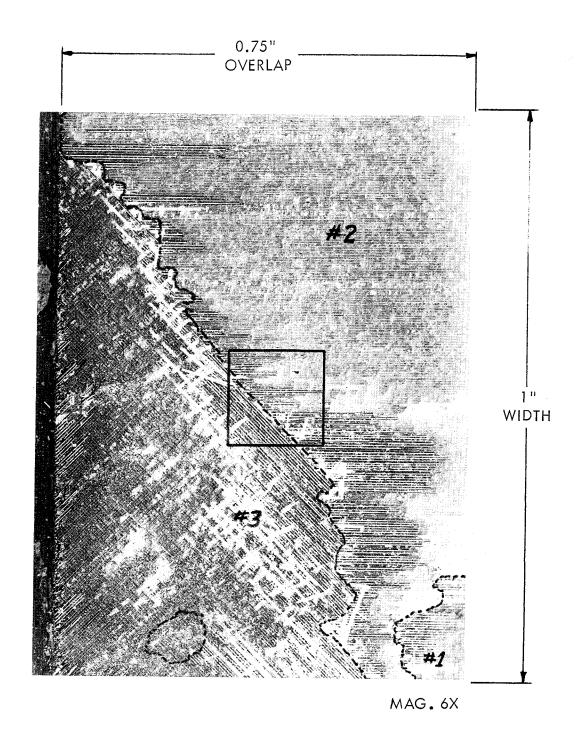
Figure 95 IA113A01 Failure Surface "B" Loaded Boron Adherend

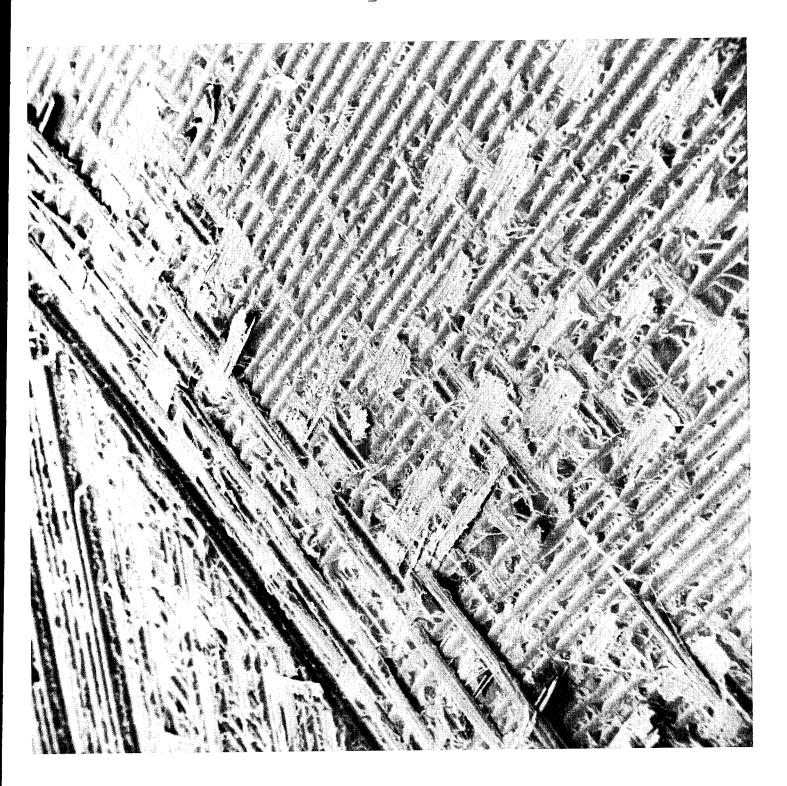
Figure 96 IA113A01 Failure Surface "A" Map
40X Magnification
(Reference Figure 94)

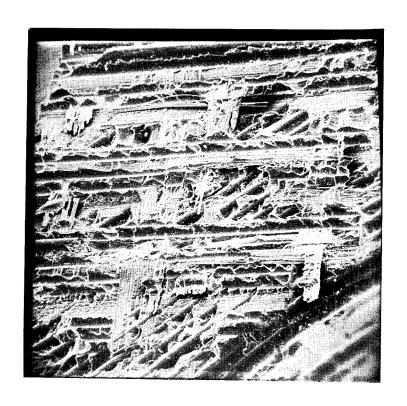
Figure 97 IA113A01 Failure Surface "A"
53X Magnification
(Reference Figure 96 Upper Left)

the fracture surface in the resin adjacent to the 45° ply exhibits a different type of failure mode. This difference is attributed to the difference in support provided to the resin by the off angle ply. This failure mode is further investigated in the photomicrographs shown in Figure 98. The surface exposed in these SEM photomicrographs is the same as designated as Section #3 in Figure 94. The failure mode in these photomicrographs is shear in the resin adjacent to the 45° ply resulting from a tension-tension fatigue load applied at 0°. The 117X and the 235X magnifications reveal a failure associated with the boron fiber which has not been detected in previous failure mode studies. The failure illustrated in this figure has the appearance of fiber surface spalling.

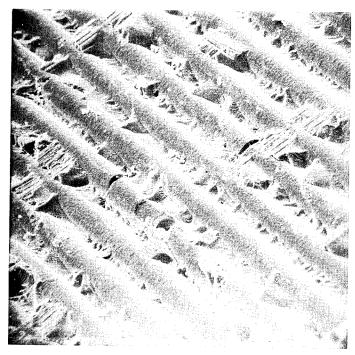
Figure 98 IA113A01 Failure Surface "A" (Reference Figure 96 Right of Center)

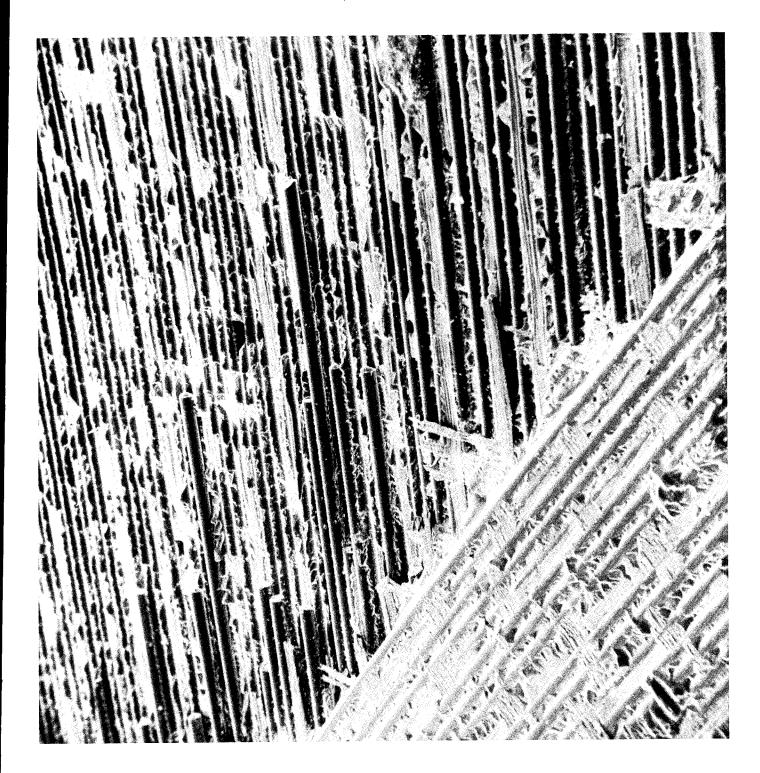
The square area outlined in Figure 95 is shown in Figure 99. The two different failure modes illustrated in Figures 96 through 98 are also visible in Figure 99. Figure 100 illustrates the same failure mode as Figure 97 and Figure 101 illustrates the same failure mode as Figure 98 since these represent the mirror images of those figures.

Figure 99 IA113A01 Failure Surface "B" Map
40X Magnification
(Reference Figure 95)

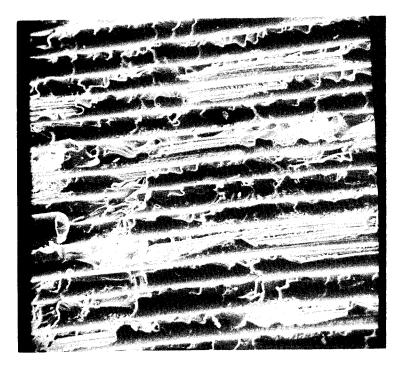
Figure 100 IA113A01 Failure Surface "B"
98X Magnification
(Reference Figure 99 Upper Center)

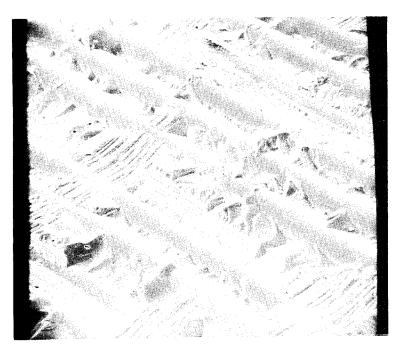
Figure 101 IA113A01 Failure Surface "B"
110X Magnification
(Reference Figure 99 Lower Left)

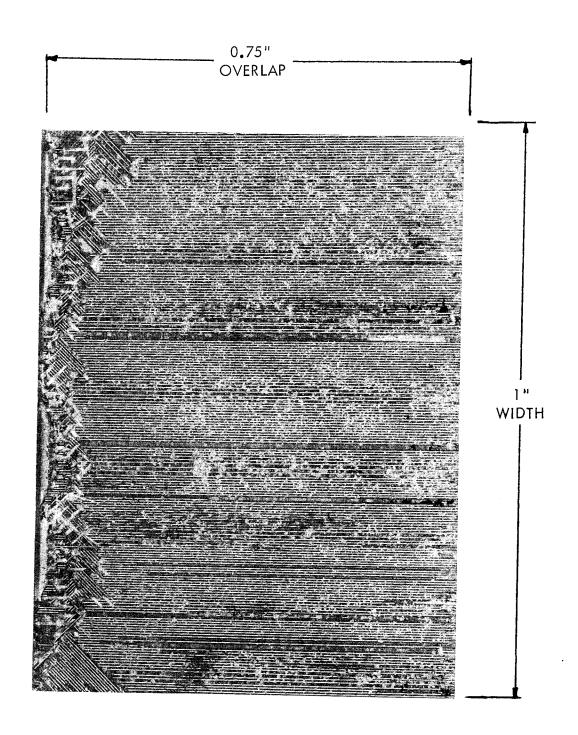
Figure 102 IA113D03 Failure Surface "A"
Boron Splice Plate
6X Magnification

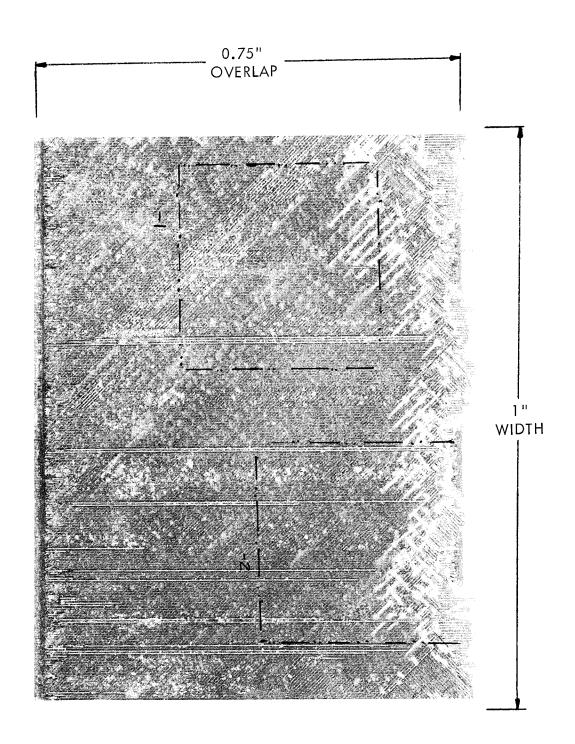
Figure 103 IA113D03 Failure Surface "B"
Boron Adherend
6X Magnification

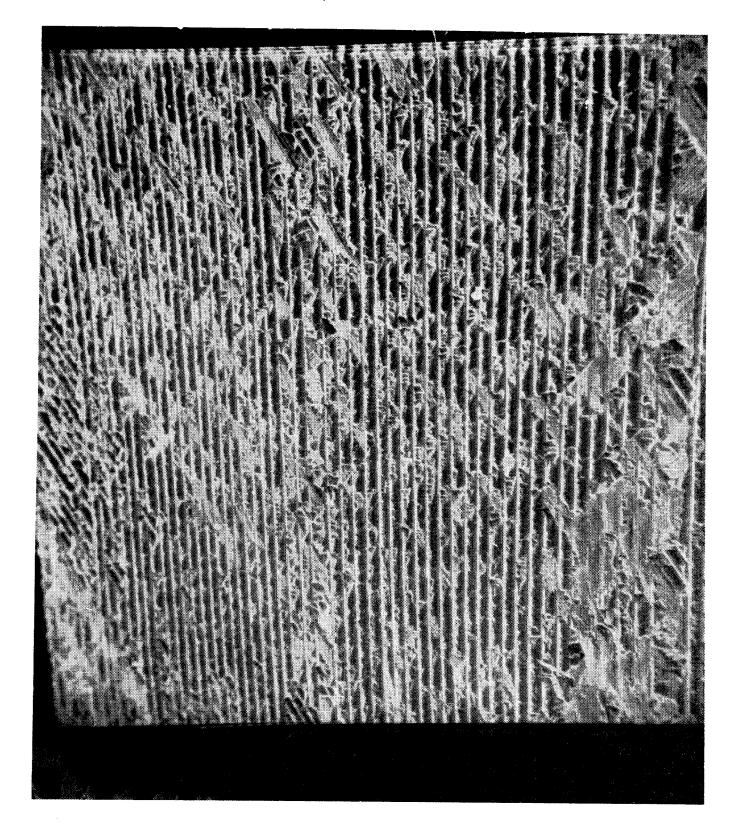
Figure 104 was taken from near the center of the specimen and Figure 105 was taken near the end of the specimen. Extensive shear fracture can be detected over the entire photograph with the exception of a few areas that appear as a peel fracture mode. This peel mode can be seen more clearly in Figure 106. This fracture compares closely with the peel mode reported in the first fracture studies conducted under this program. Figure 107 illustrates that the shear fracture is not confined to one interface at a given location. This figure shows failure occurring between the resin and the 0° ply and the 45° ply in the same location. These same failures are shown in Figures 108 and 109. Presence of some peel mode failure and multi-layer shear failure are believed to be the reasons why this boron-to-boron specimen exhibited a lower strength, generally, than the boron to metal specimens.

Figure 104 IA113D03 Failure Surface "A", 40X Magnification

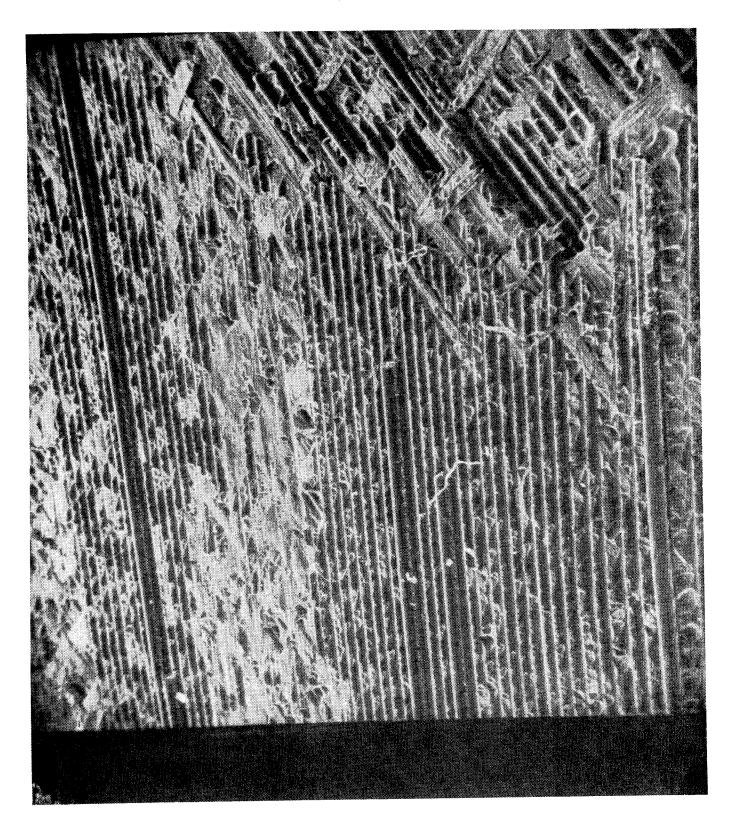
Figure 105 IA113D03 Failure Surface "B", 40X Magnification (Reference Figure 103 Near Edge)

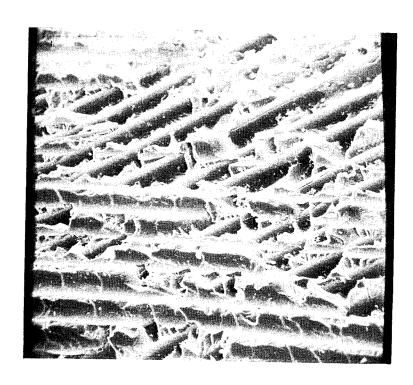
Figure 107 Enlargement of Figure 104
Upper Center, 100X Magnification

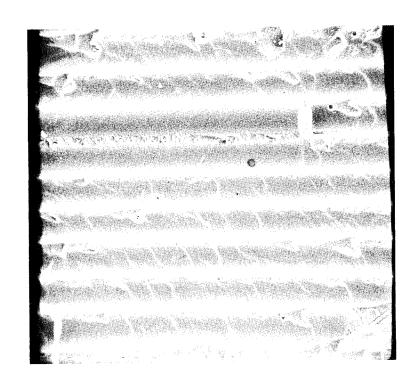
Figure 108 Enlargement of Figure 105
Just Below Center, 117X Magnification

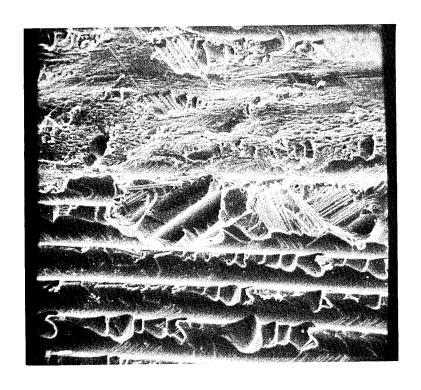
Figure 109 Enlargement of Figure 105
Near Center, 110X Magnification

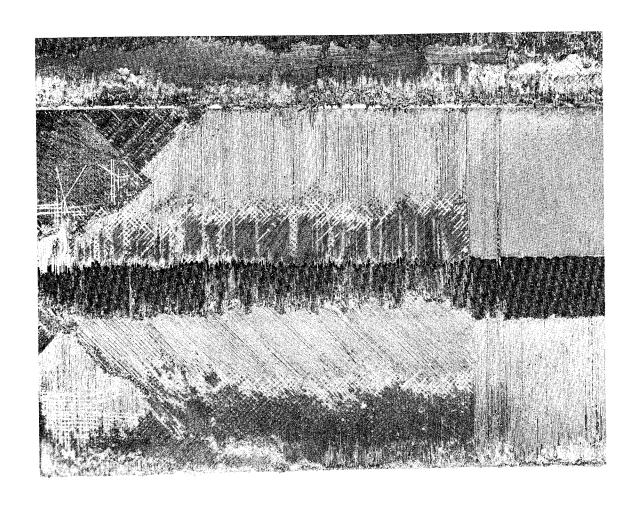
This is a 3-inch wide Configuration A single splice lap joint compressive fatigue loaded to a stress ratio of $R = \pm 10.0$. Figure 110 is a 2X magnification overall view of the fractured surface. No new failure modes are apparent in any of the 3-inch wide specimens investigated. However, the increase in joint area allows for more fracture modes within one specimen as illustrated in Figure 110. One factor noted in the wider joints was the increased amount of crazed or granular resin over the entire fracture surface.

Figure 110 Specimen IIA11CO3 - Overall View, 2X Magnification

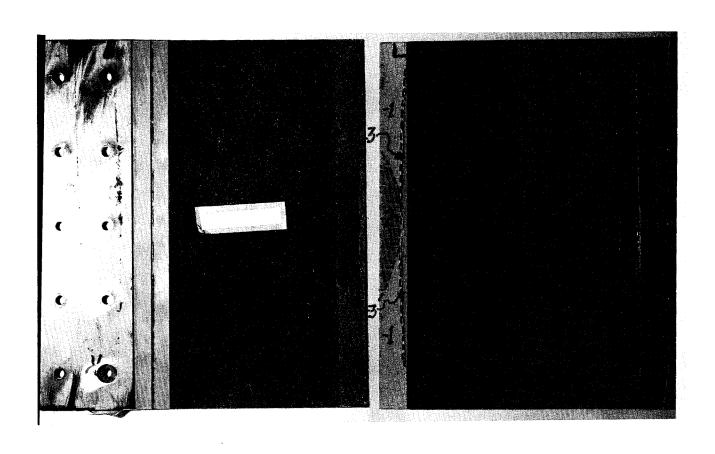
The square areas outlined in Figure 111, Surface B, were investigated by SEM photomicrographs. Figure 112 represents the -1 area and illustrates the failure modes discussed under Section #1 above. Figure 113 represents the -2 area and illustrates the failure modes discussed under Section #2 above.

Figure 111 Specimen IIIA12A01 - Overall View, 1/3X Magnification

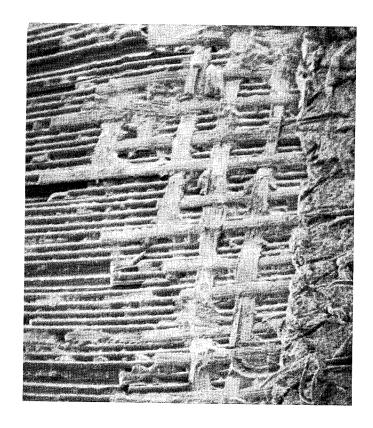
In Figure 111, Surface B, Section #1, the failure mode was shear within the adhesive along the plane in the scrim cloth. In Section #3 the failure mode was primarily shear between the boron filaments and resin matrix with some shear between the resin matrix and 104 carrier scrim.

Figure 112 SEM Photomicrograph of -1 Square in Figure 111 Surface B

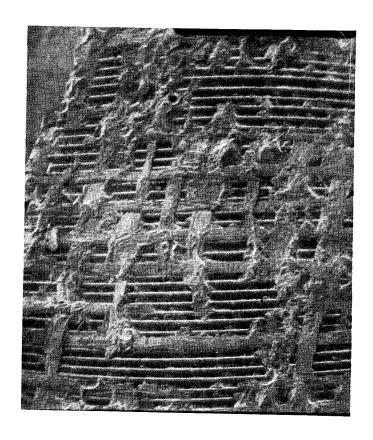
Figure 113 SEM Photomicrograph of -2 Square in Figure 111 Surface B

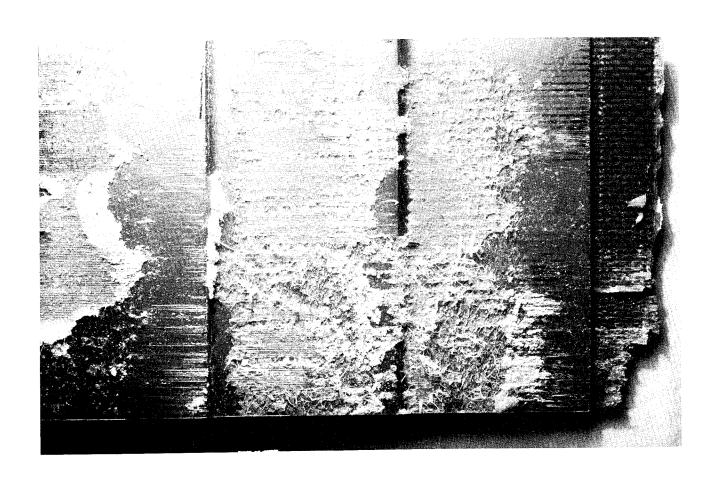
This is a one-inch wide Configuration B step-lap joint specimen, loaded in compression to a stress ratio of $R = \pm 10.0$. A 4X view of the failure surface is shown in Figure 114. For step-lap joints, the failure modes are generally mixed; i.e., some bond failure, some delamination, and some net section for the thinnest step in the boron. However, when loaded in compression fatigue, the bondline is usually the weakest link, as evidenced in the micrograph.

Figure 114 Specimen IB111CO1 - Surface A - 4X Magnification

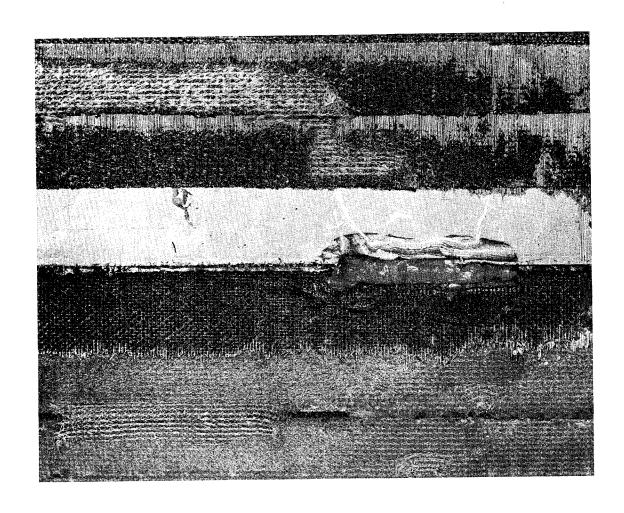
As seen in Figure 115, when failure takes place in the bond line, much damage occurs to the adhesive layer. Sections #1 and #2 noted on Figure 116 were examined further on the SEM. As evidenced in Figure 117, the failure mode at the first step consists of shear failure within the adhesive (along the plane of the scrim cloth) changing abruptly to shear failure between the resin matrix and the outer ply of boron filaments. Figure 118, representing Section #2 of Figure 116, shows the shift in failure mode from shear between the resin matrix and outer ply of boron filaments (in the first step) to shear within the adhesive along the plane of the adhesive scrim cloth.

Figure 115 Specimen IIB31A05 - Overall View - 2X Magnification

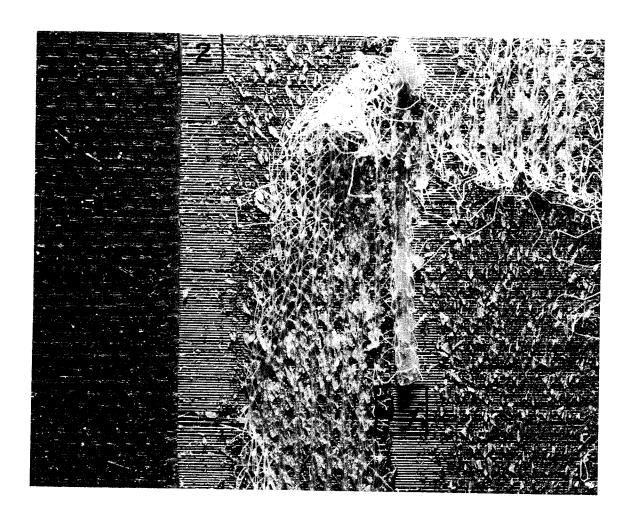
This is a three-inch wide Configuration B step-lap joint specimen, loaded in tension-tension fatigue at a stress ratio of R = +0.1. An overall view of the joint is shown in Figure 115. It will be seen in magnified view (6X) Figure 116, that the joint failed in the bond line on two steps and in net section tension in the third step.

Figure 116 Specimen IIB31A05 - Surface B - 6X Magnification

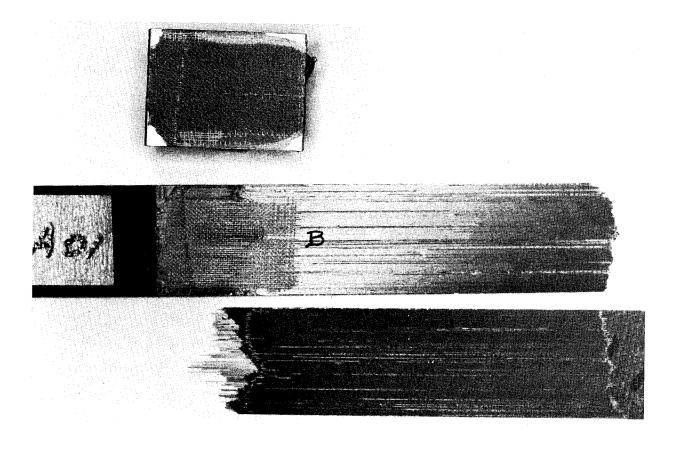
Figure 119 Specimen IC111AO1 - Overall View

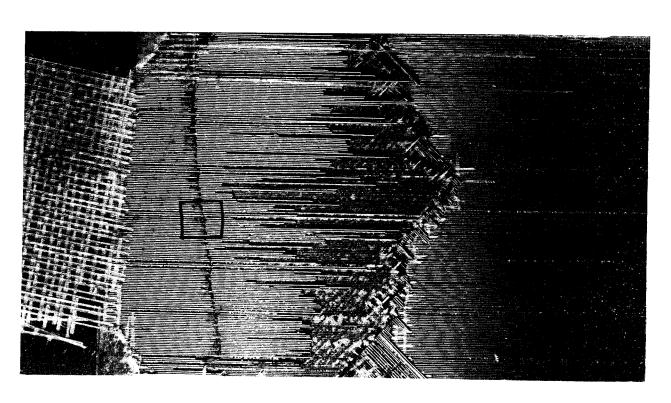
Figure 119 shows the general failure modes of this specimen which consist of a laminate-to-tee disbond, and fracture of the laminate. Failure Surface B, Figure 120, magnification 4X, indicates that the bond failed primarily in shear at the glass carrier scrim/resin interface in the surface ply of boron culminating in a static peel mode. It is apparent that the effects of side loading and laminate bending have caused plies near the surface to fail, thus propagating into total laminate failure.

Figure 120 Specimen IC111AO1 - Magnification 4X - Surface "B"

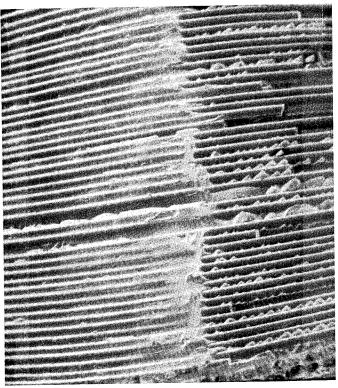
Figure 121 SEM Photomicrograph of Area Outlined in Figure 120

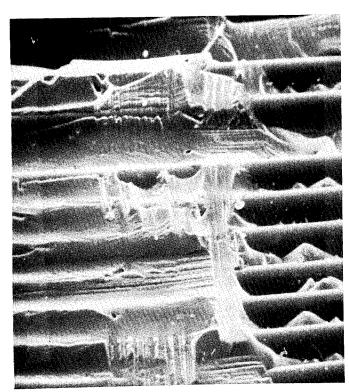
Figure 122 SEM Photomicrograph of Area Outlined in Figure 121

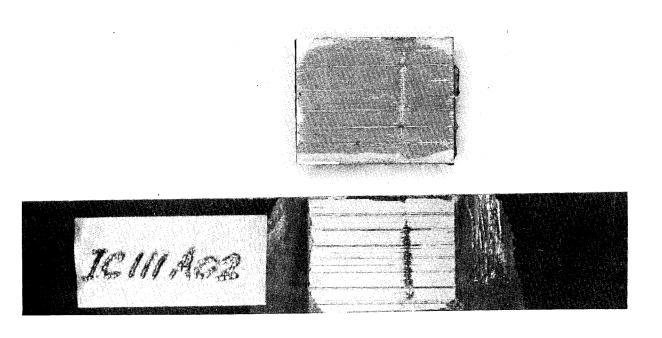
This specimen was loaded similar to IC111A01 except that the maximum tensile stress was 30,000 psi with a side load of 60 lbs. An overall view of the joint, Figure 123, shows that failure again initiated at the ends and propagated toward the center. Microscopic inspection, Figure 124, revealed a tension shear fracture mode at the ends but changing to a peel mode at final failure. A 20X SEM photomicrograph of a section of this specimen is shown in Figure 125. A pronounced narrow band of peel, or flatwise tension fracture mode, is evident (arrow) with striations also being visible. The striations initiated in the area where the failure mode changes from shear to peel. Although apparent on only one side of the final fracture site, the striations were observed microscopically on both sides of the final failure zone.

Figure 123 Specimen IC111AO2 - Overall View

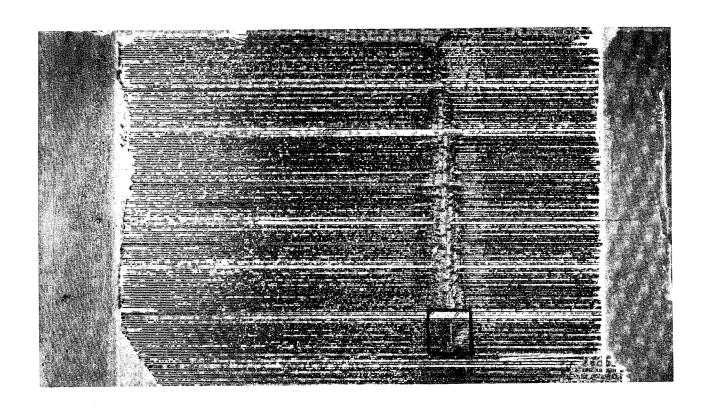
Figure 124 Specimen IC111A02 - Magnification 4X - Surface "B"

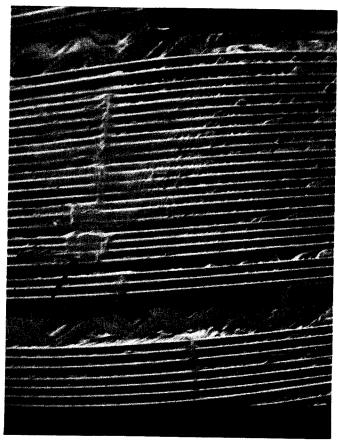
Figure 125 SEM Photomicrograph of Section from Area Designated by Square in 124

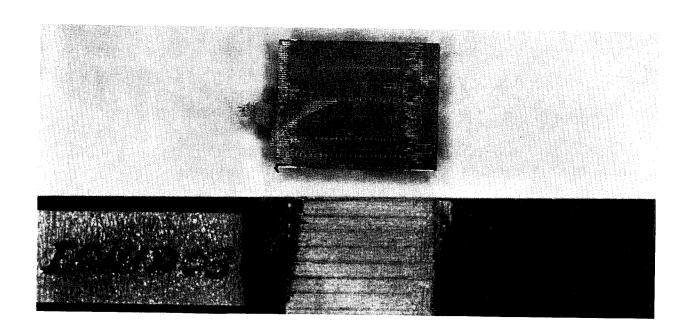
This is a Configuration C specimen which was subjected to an axial load of 47,500 psi and an increasing side load which reached 105 pounds, and incurred a deflection of 0.190 inches at failure. An overall view of the fracture surfaces is shown in Figure 126. Microscopic examination (Figure 127) indicates failure due to overload normal to the bond line. Without the presence of cyclic axial loads, the initial failure at the ends of the tee joint appear to be a tension or a tension/peel combination. This fracture then rapidly changed into a shear plus tension mode.

Figure 126 Specimen IC111D03 - Overall View

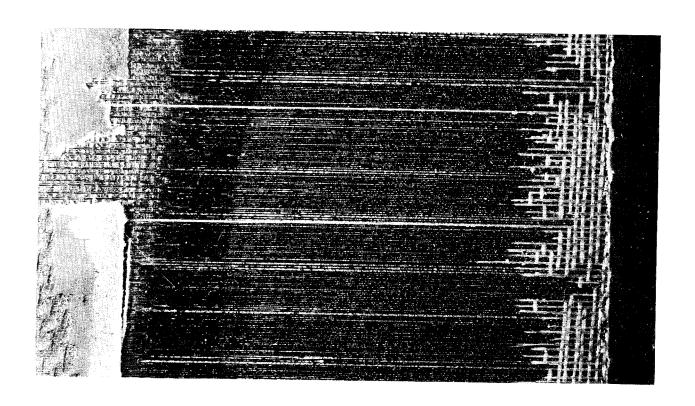
Figure 127 Specimen IC111D03 - Surface "B" - Magnification 4X

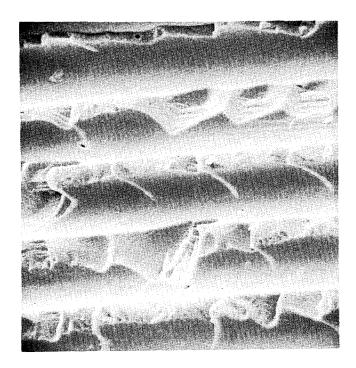
- o Shear fatigue failure in resin parallel to fiber regardless of stress level but subjected to a stress ratio of R = -1.0 as illustrated in Figure 128.

Figure 128 Shear Failure in Matrix Subjected to a Stress Ratio of R = -1.0

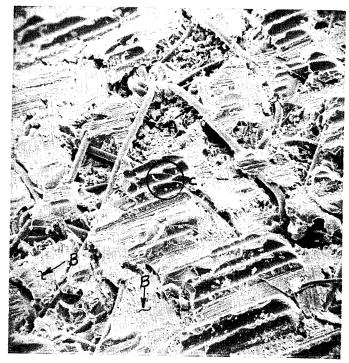
Figure 129 Shear Failure in Matrix Subjected to Tension-Tension Fatigue, R = +0.1

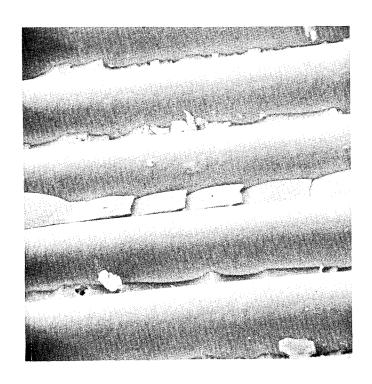
Figure 131 Shear Failure in Matrix Subjected To Static Compression

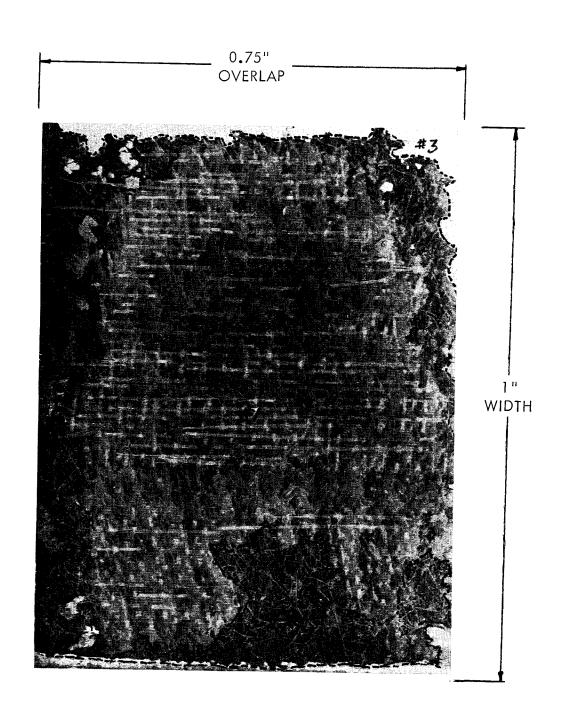
Figure 132 Cohesive Shear in the Adhesive, Illustrated in Section 2

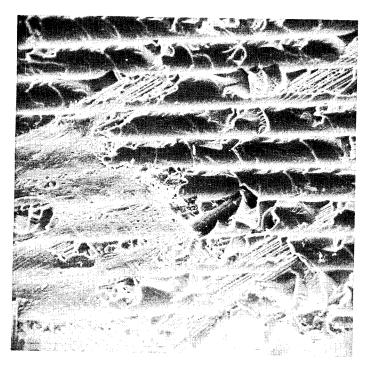
Figure 133 Spalling of Boron Fibers in 45° Plies Subjected to a Tension-Tension Fatigue Load Applied at 0°

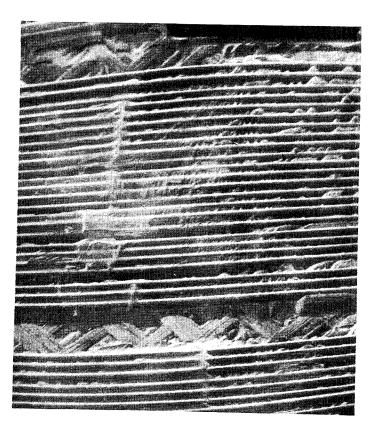
Figure 134 Peel Failure in Matrix Subjected to Static Tension
